15. Supplementary Notes			
16. Abstract  About 11:06 p.m. on June 5, 1975, a Reading Company commuter train struck a tractor-semitrailer (truck) at a grade crossing near Yardley, Pennsylvania. The truck was transporting three coils of steel, two of which penetrated the first commuter car. The three occupants of the lead car were killed and an occupant of the second car was injured slightly. The truckdriver was uninjured. The semitrailer was torn from the tractor and damaged beyond repair and the lead commuter car was damaged extensively.  At the time of the collision, the automatic grade crossing signal system was functioning. The truckdriver said he had not seen or heard the warning signals.  The National Transportation Safety Board determines that the probable cause of the accident was the failure of the truckdriver to stop the truck in accordance with the warning signals.

About 11:06 p.m. on June 5, 1975, a Reading Company commuter train struck a tractor-semitrailer (truck) at a grade crossing near Yardley, Pennsylvania. The truck was transporting three coils of steel, two of which penetrated the first commuter car. The three occupants of the lead car were killed and an occupan

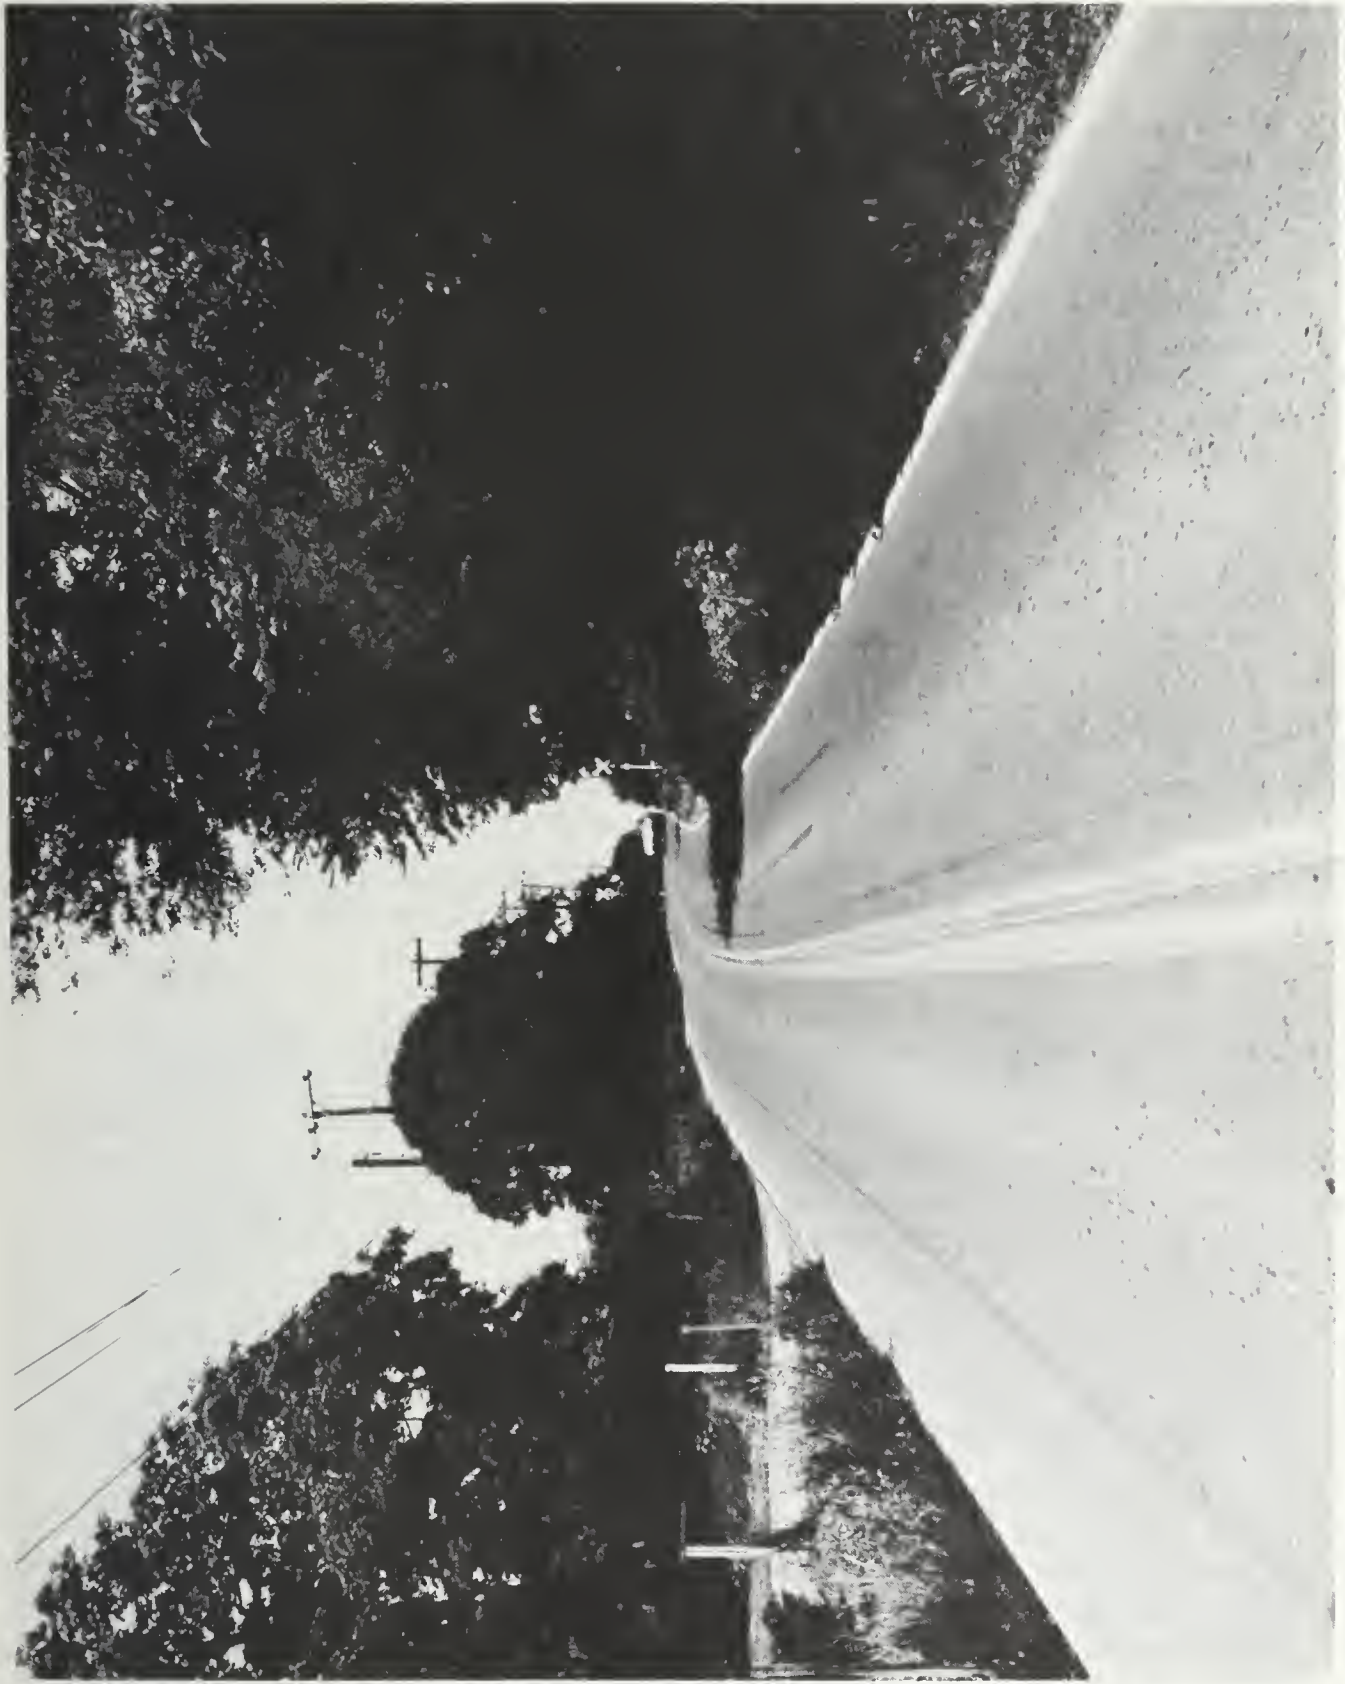
Three hundred feet south of the crossing, the truckdriver's view of the grade crossing and of the crossing's warning signals was obscured by the structure of the tractor and the adverse weather conditions.

Figure 2. Stony Hill grade crossing from direction of truck.

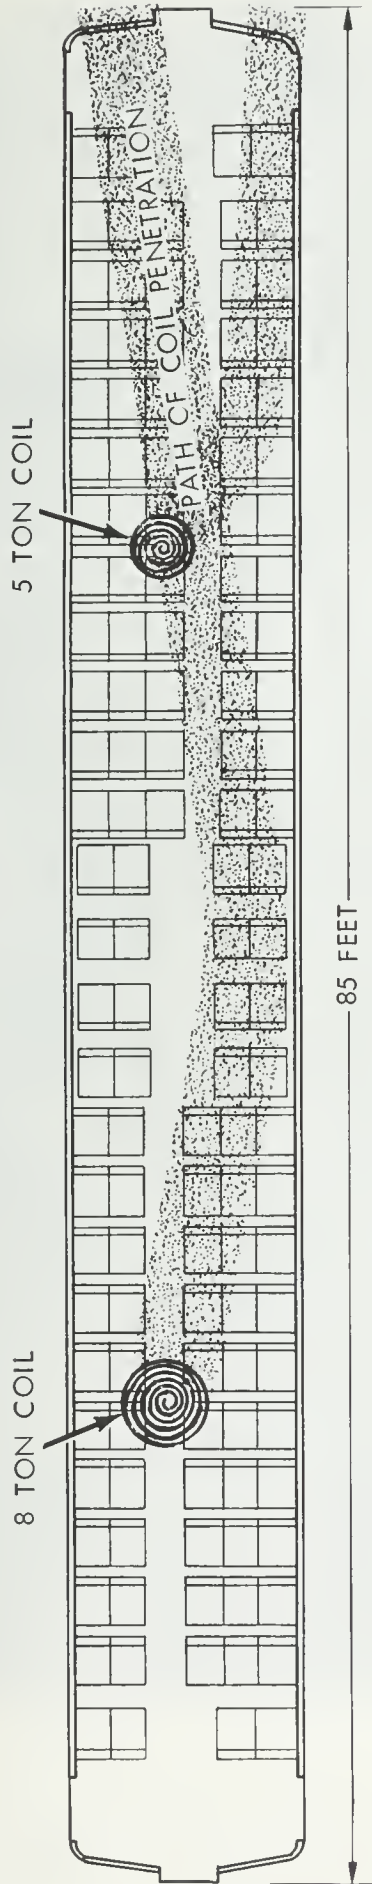
The Train -- The 8-ton coil of steel on the rear of the trailer struck the left front collision post of the lead car 38 inches above the

Figure 4. Plan view - Reading Company commuter car and coil penetration.

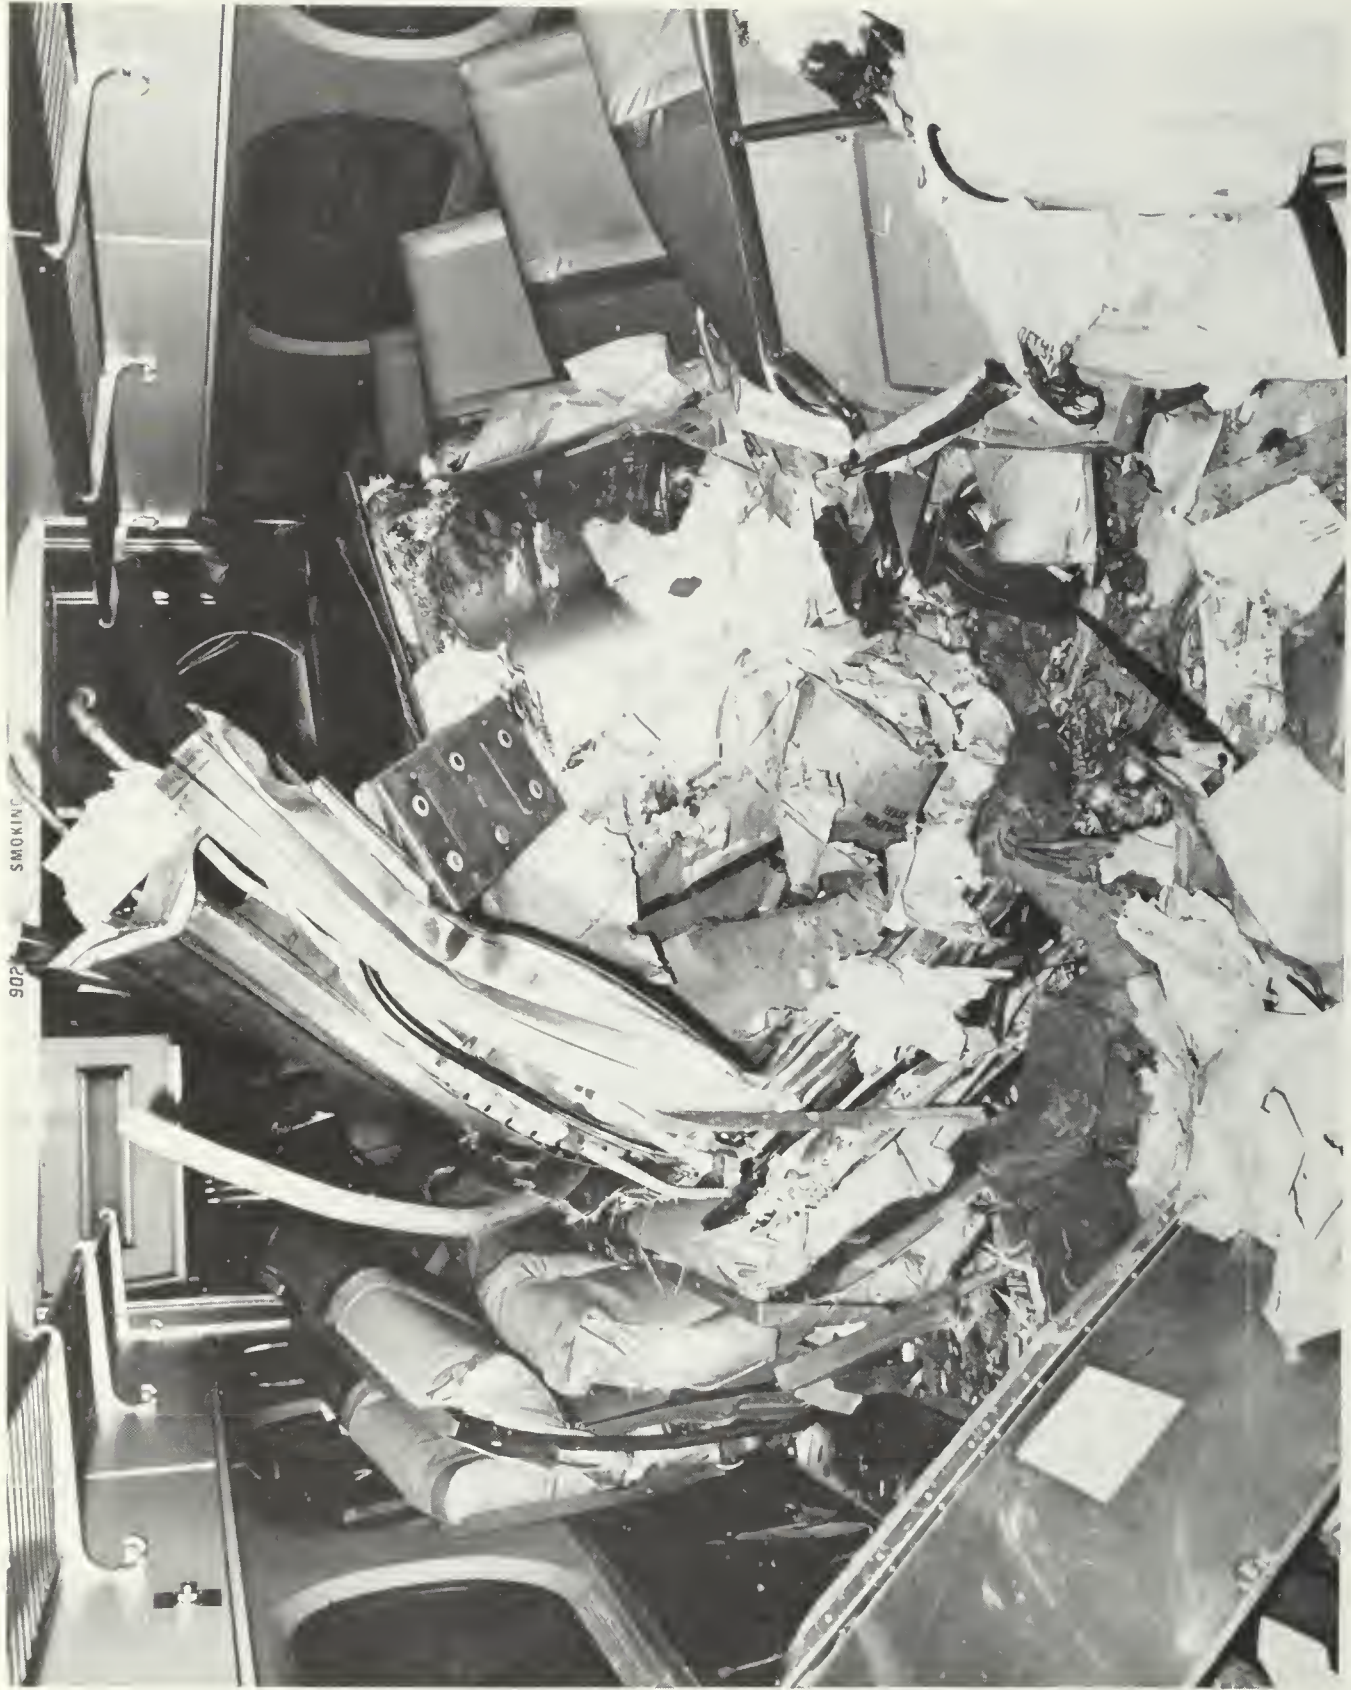
The body of the engineer was found on the floor in the aisle to the rear of the 5-ton coil, about 22 feet from the control station. The trainman and the passenger were found pinned in their seats by the collapsed vestibule partitions. The center vestibule compartment had been dislodged rearward 26 feet, to the vicinity of the 23rd row of seats, by the 8-ton coil.

Figure 5. Interior of railcar 9024 after 8-ton coil penetration.

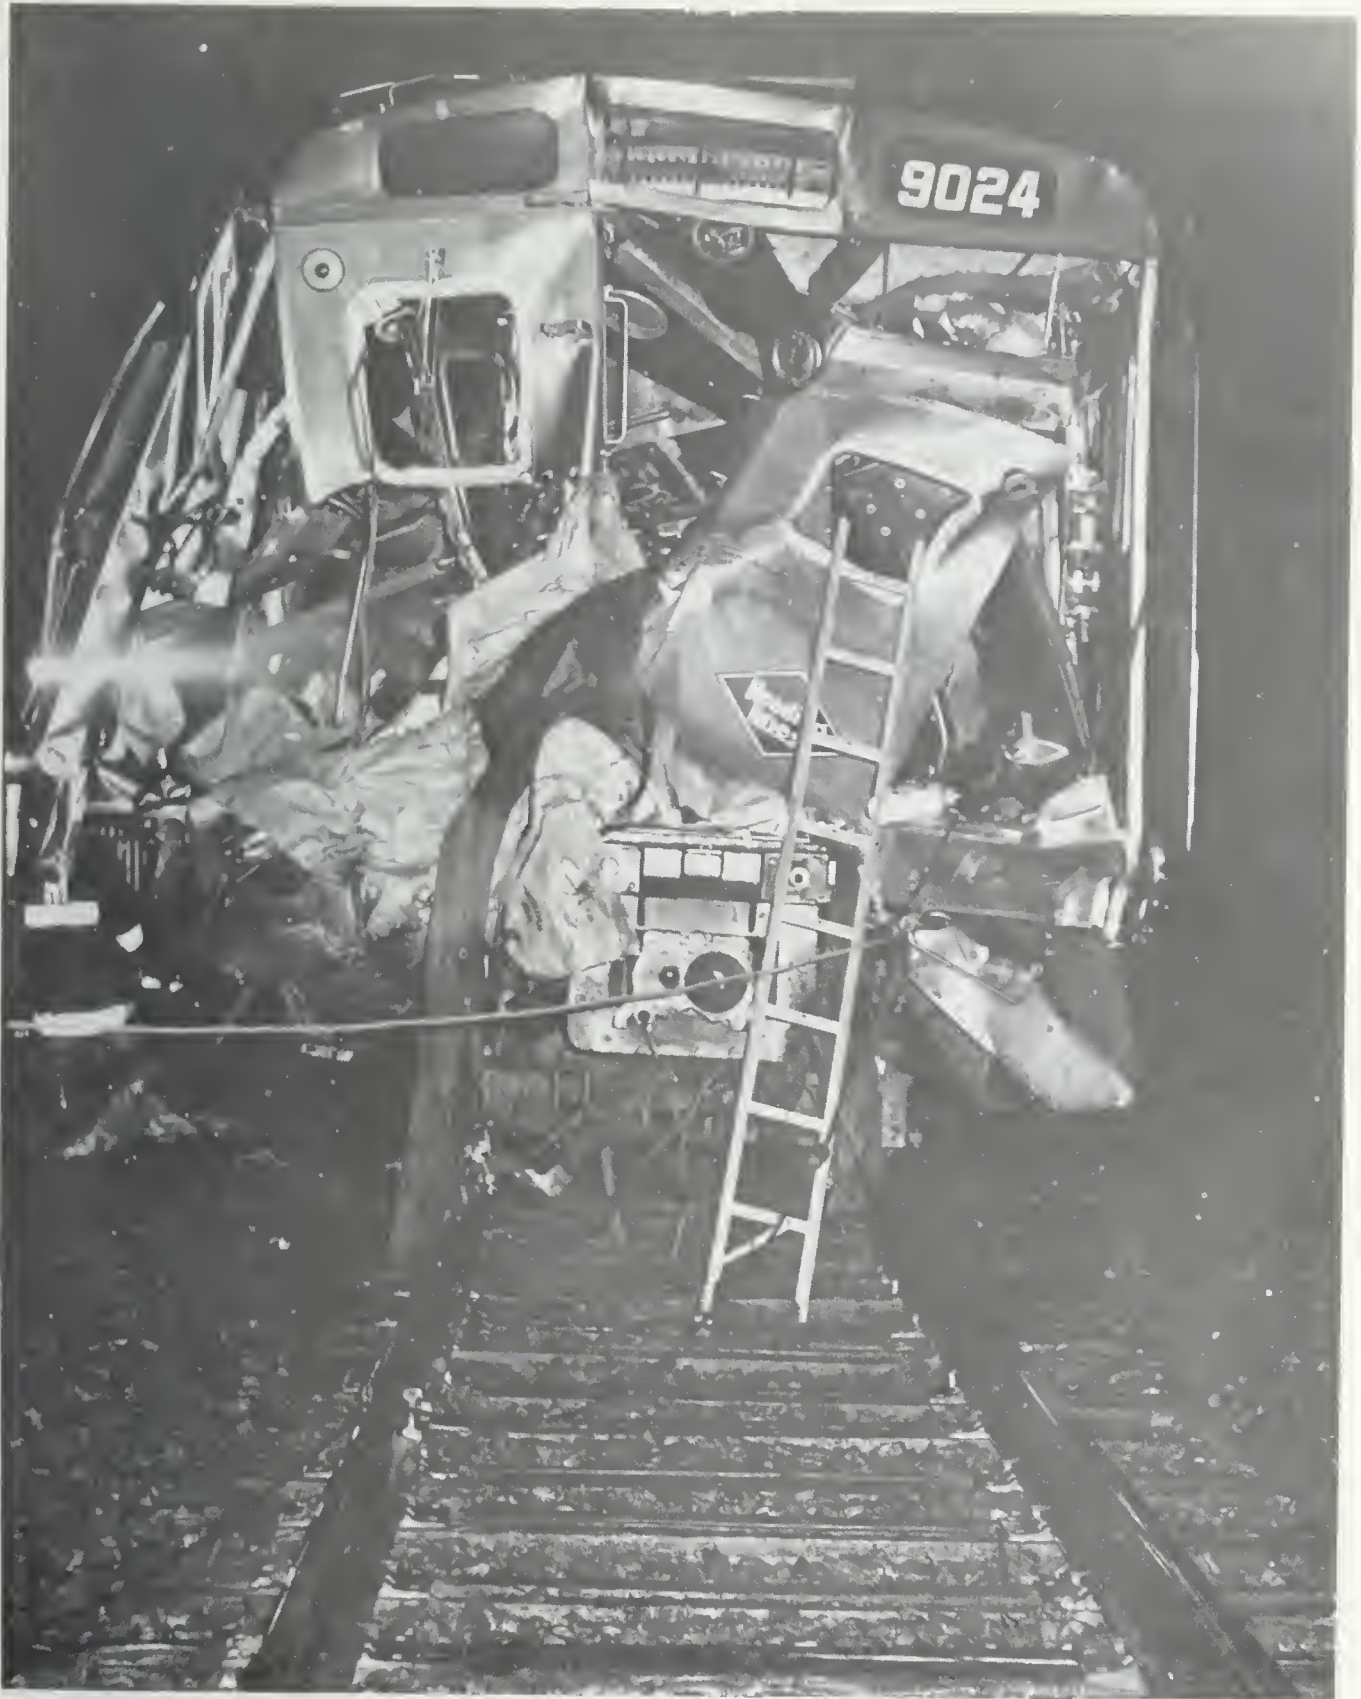
Figure 6. External view of 9024.

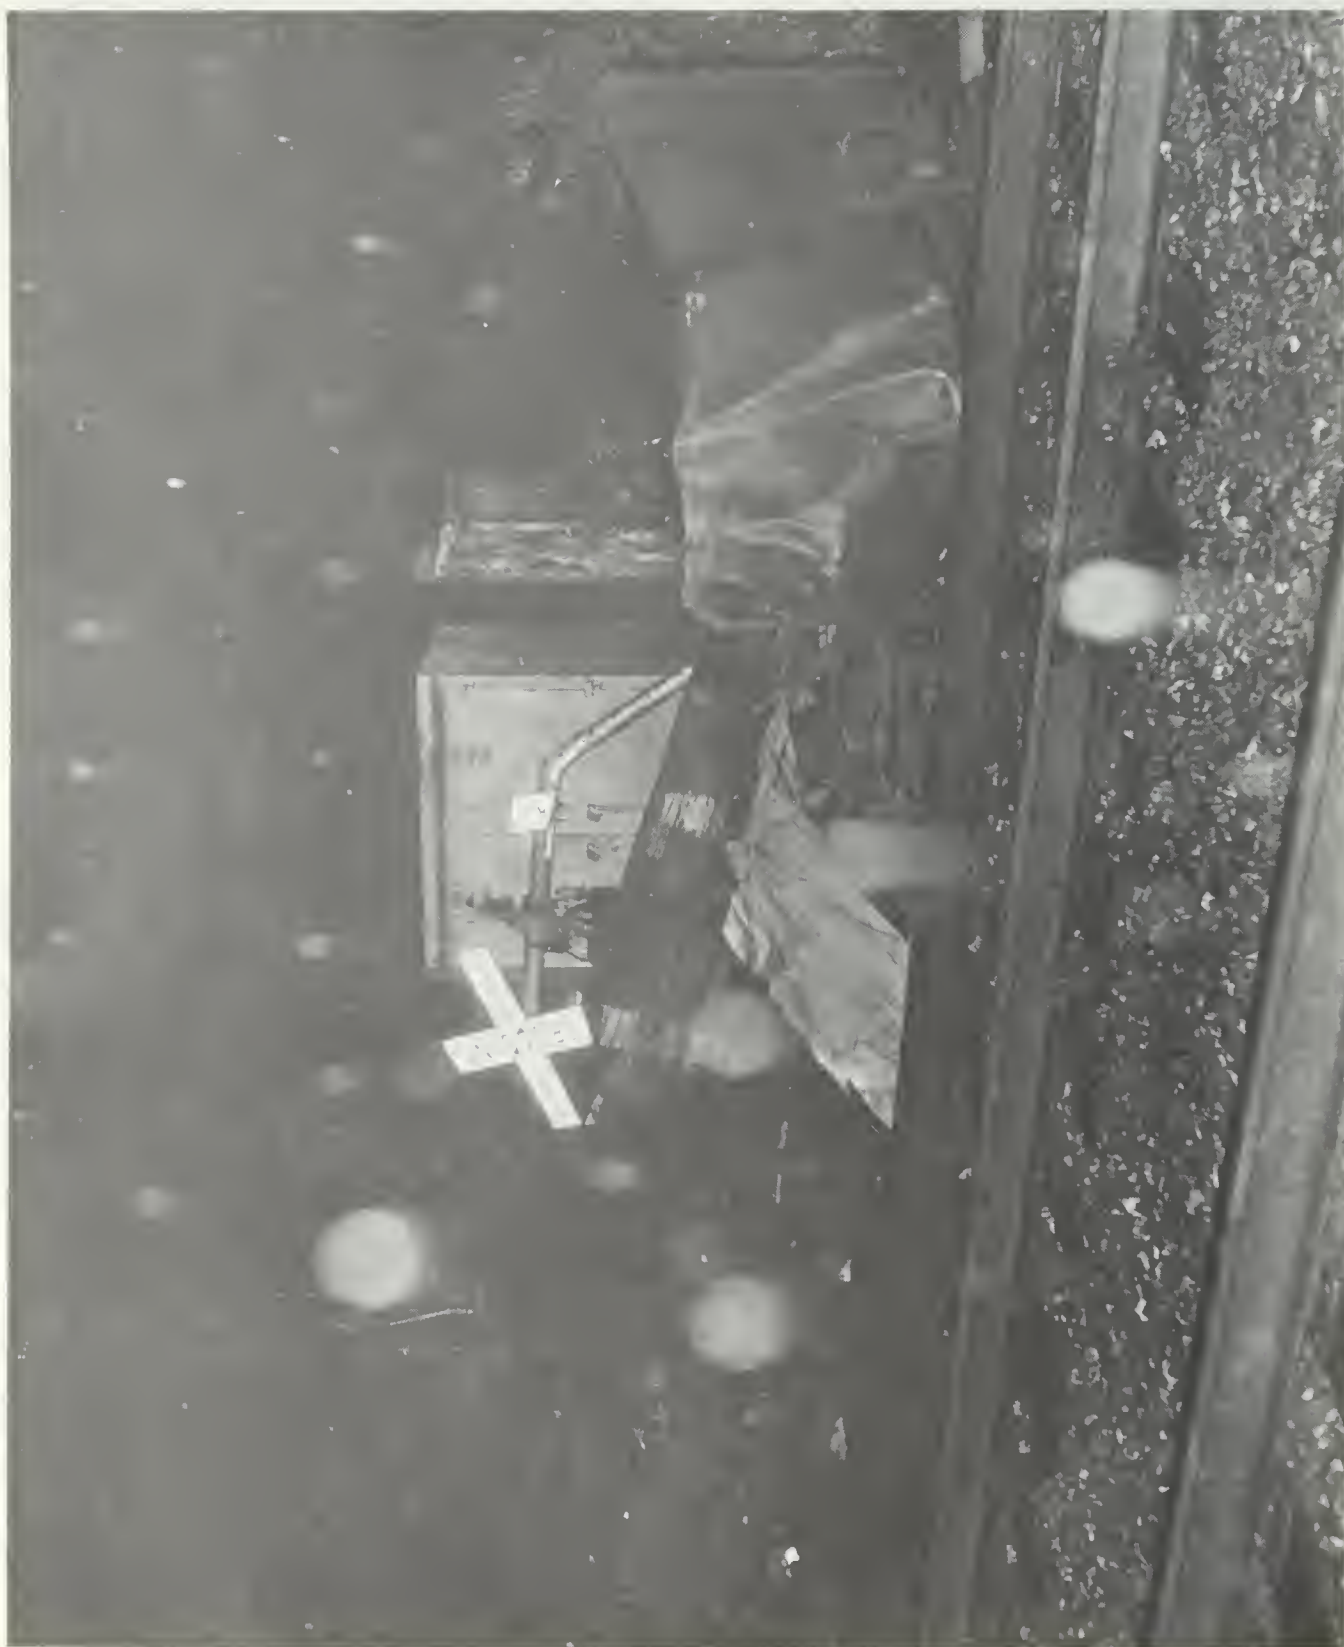
The Truck -- The trailer was torn loose from the tractor at the fifth-wheel assembly with only minor damage to the tractor because the fifth wheel separated from the tractor chassis. The trailer was rotated clockwise westward along the track, striking and dislodging the automatic warning signal on the north side of the track. As the trailer rotated off the track and away from the train, it contacted the right side of the train. The trailer came to rest 58 feet west of the crossing, facing the southeast, its left rear corner resting against a catenary pole and its right front corner resting on the ground just clear of the track ballast. The trailer's tandem axle suspension came to rest about 25 feet north of the catenary pole. (See Figure 7.)

The Signal Equipment -- The automatic warning signal in the northwest quadrant of the grade crossing was struck by the trailer, torn from its base, and damaged extensively as the signal and the trailer were carried westward by the train. The junction box, telegraph relay case, battery well, and a junction box attached to the catenary pole were damaged from impact with the dislodged warning signal and with debris from the trailer.

Figure 7. The trailer against catenary pole and highway signal mast

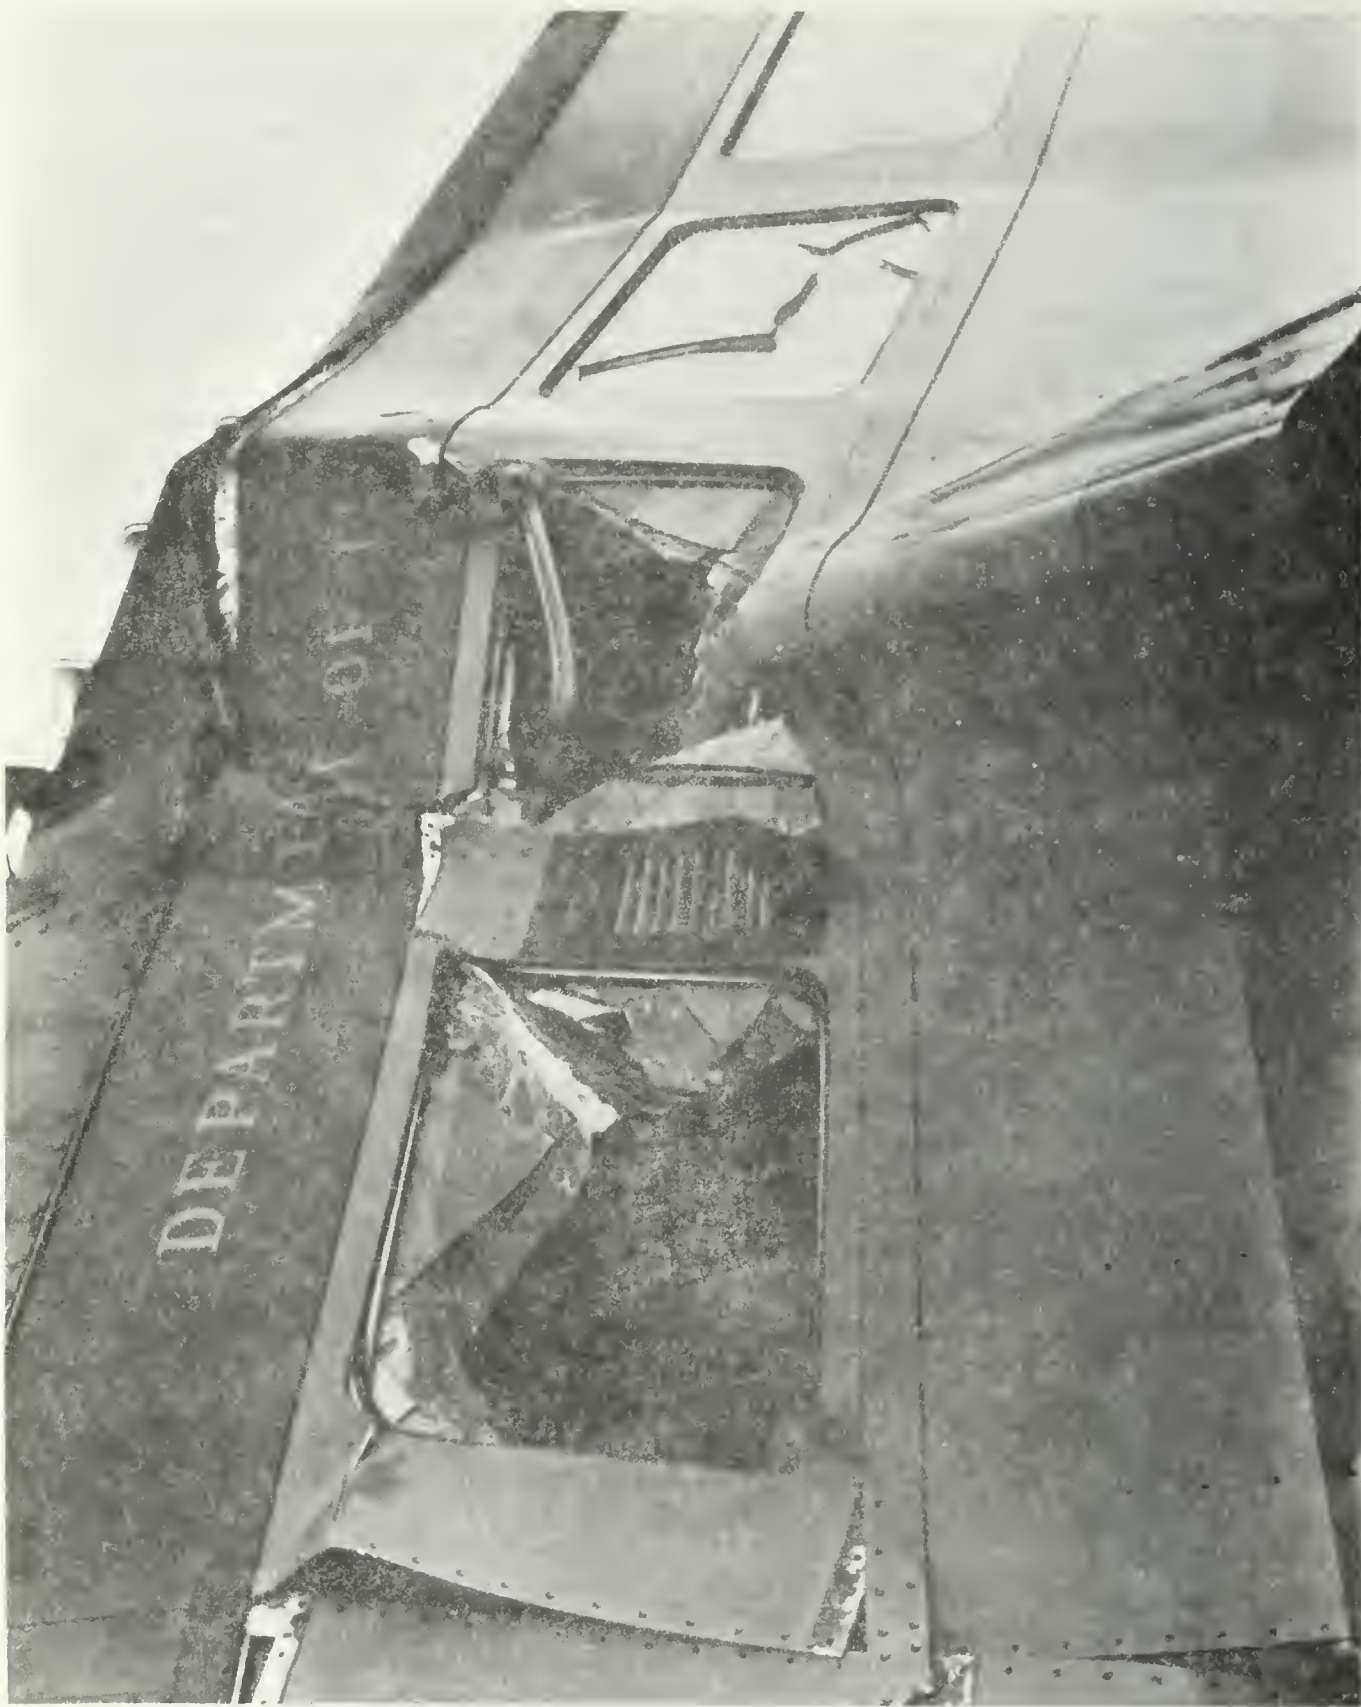
Figure 1. Damaged dome car of train No. 5.

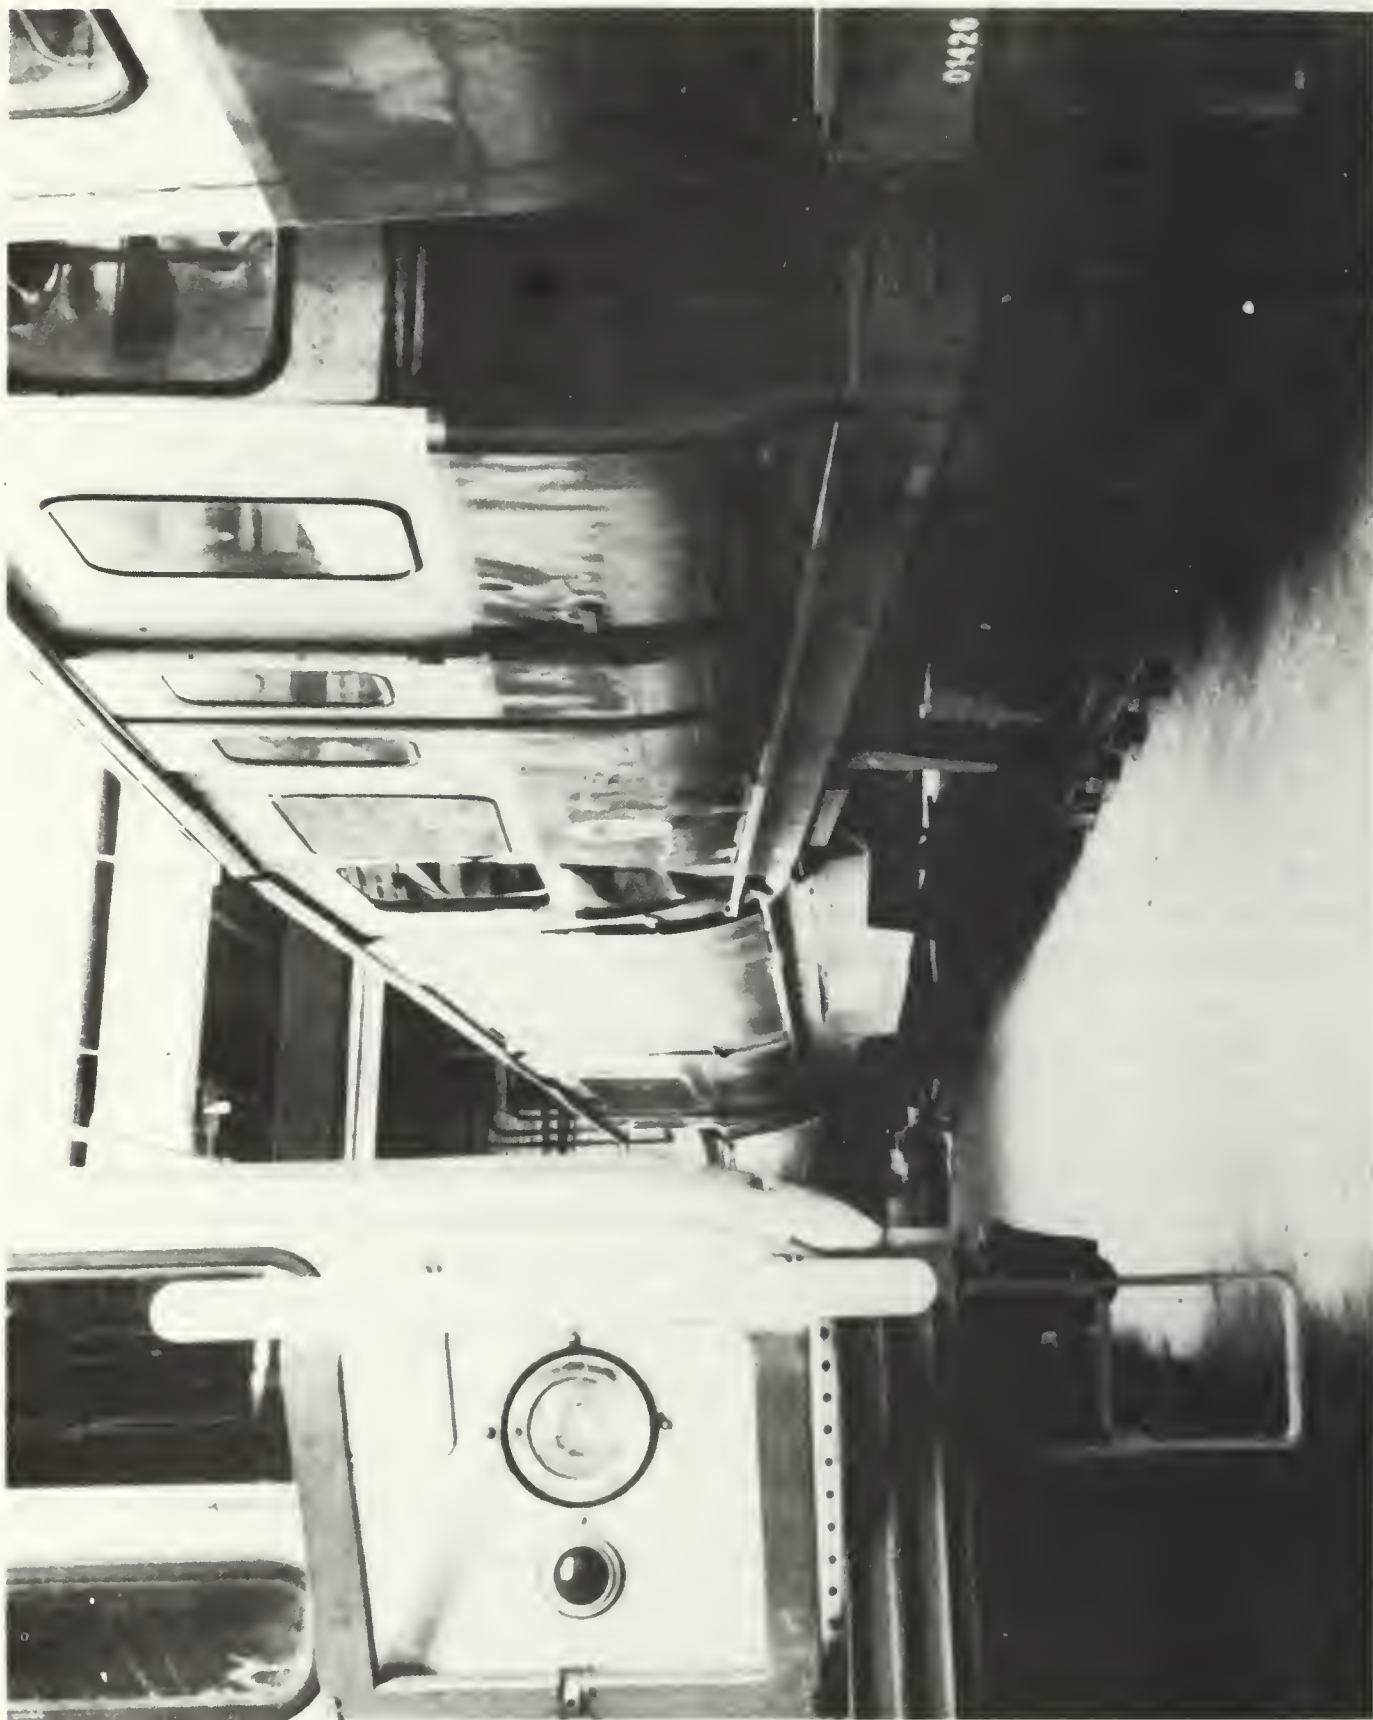
The underframe of the last car of train 1402 (a "Bluebird") sustained plastic deformation at several symmetrically located positions along the side sills. At the end which was hit, the underframe was crushed about 8 inches and the superstructure was crushed about 19 inches, mostly near the roof. (See Figure 3.) The anticlimbers on the other three cars in train 1402 were damaged slightly but showed no other marks from the crash.

Figure 3. Crash damage to the last car of train 1403.

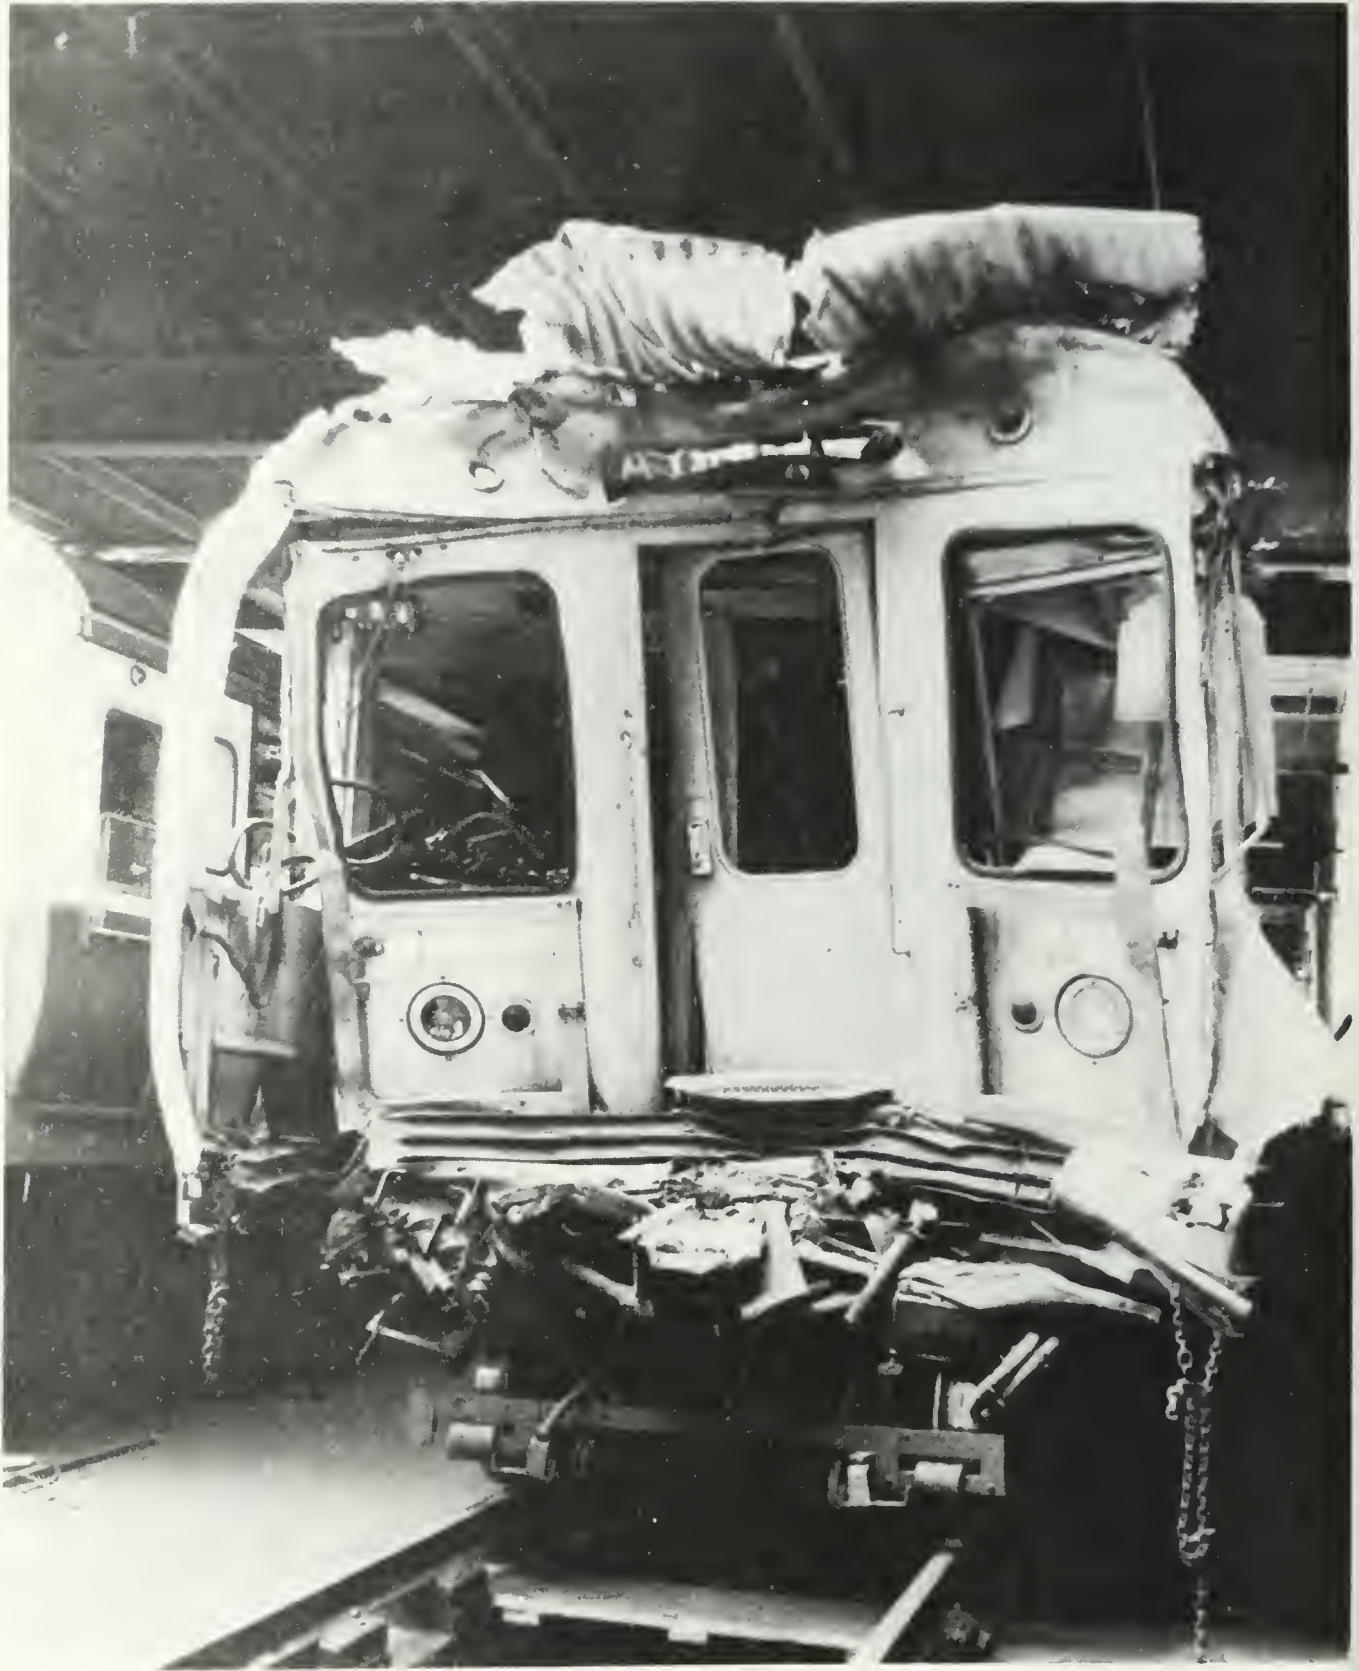
Figure 4. Crash damage to forward end of the first car of train 1604.

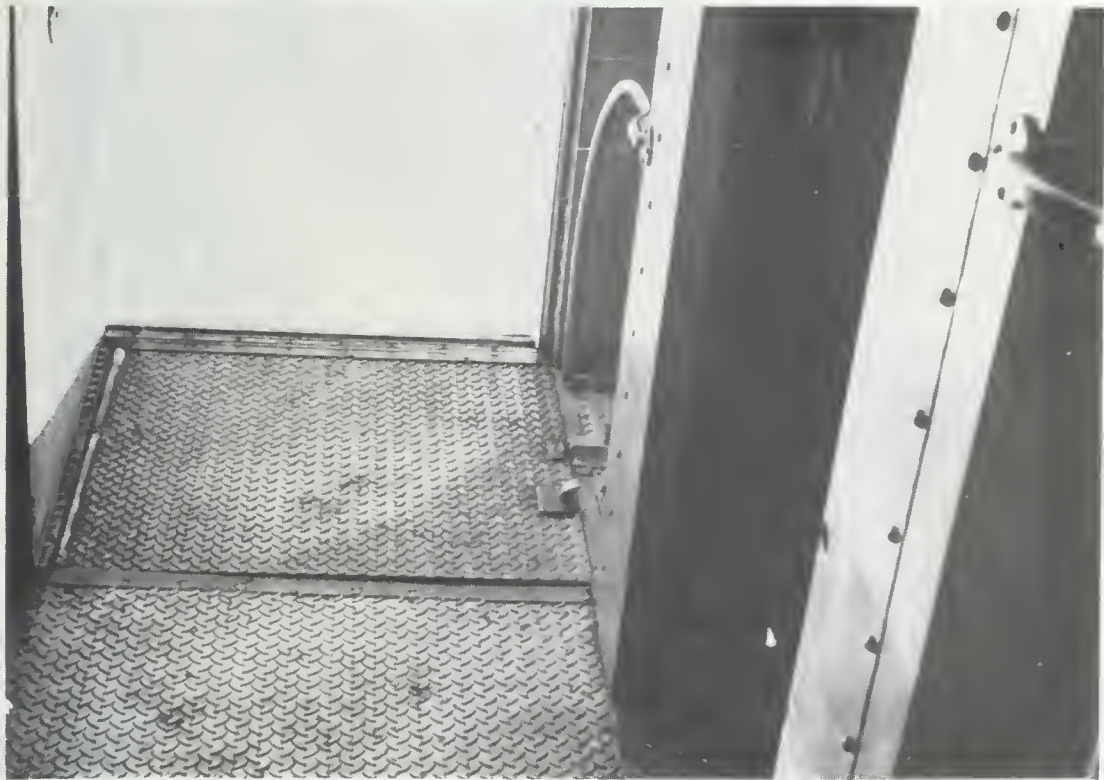
Figure 1. View of vestibule from bottom doors as car rests on its side, showing lack of handholds and footholds.

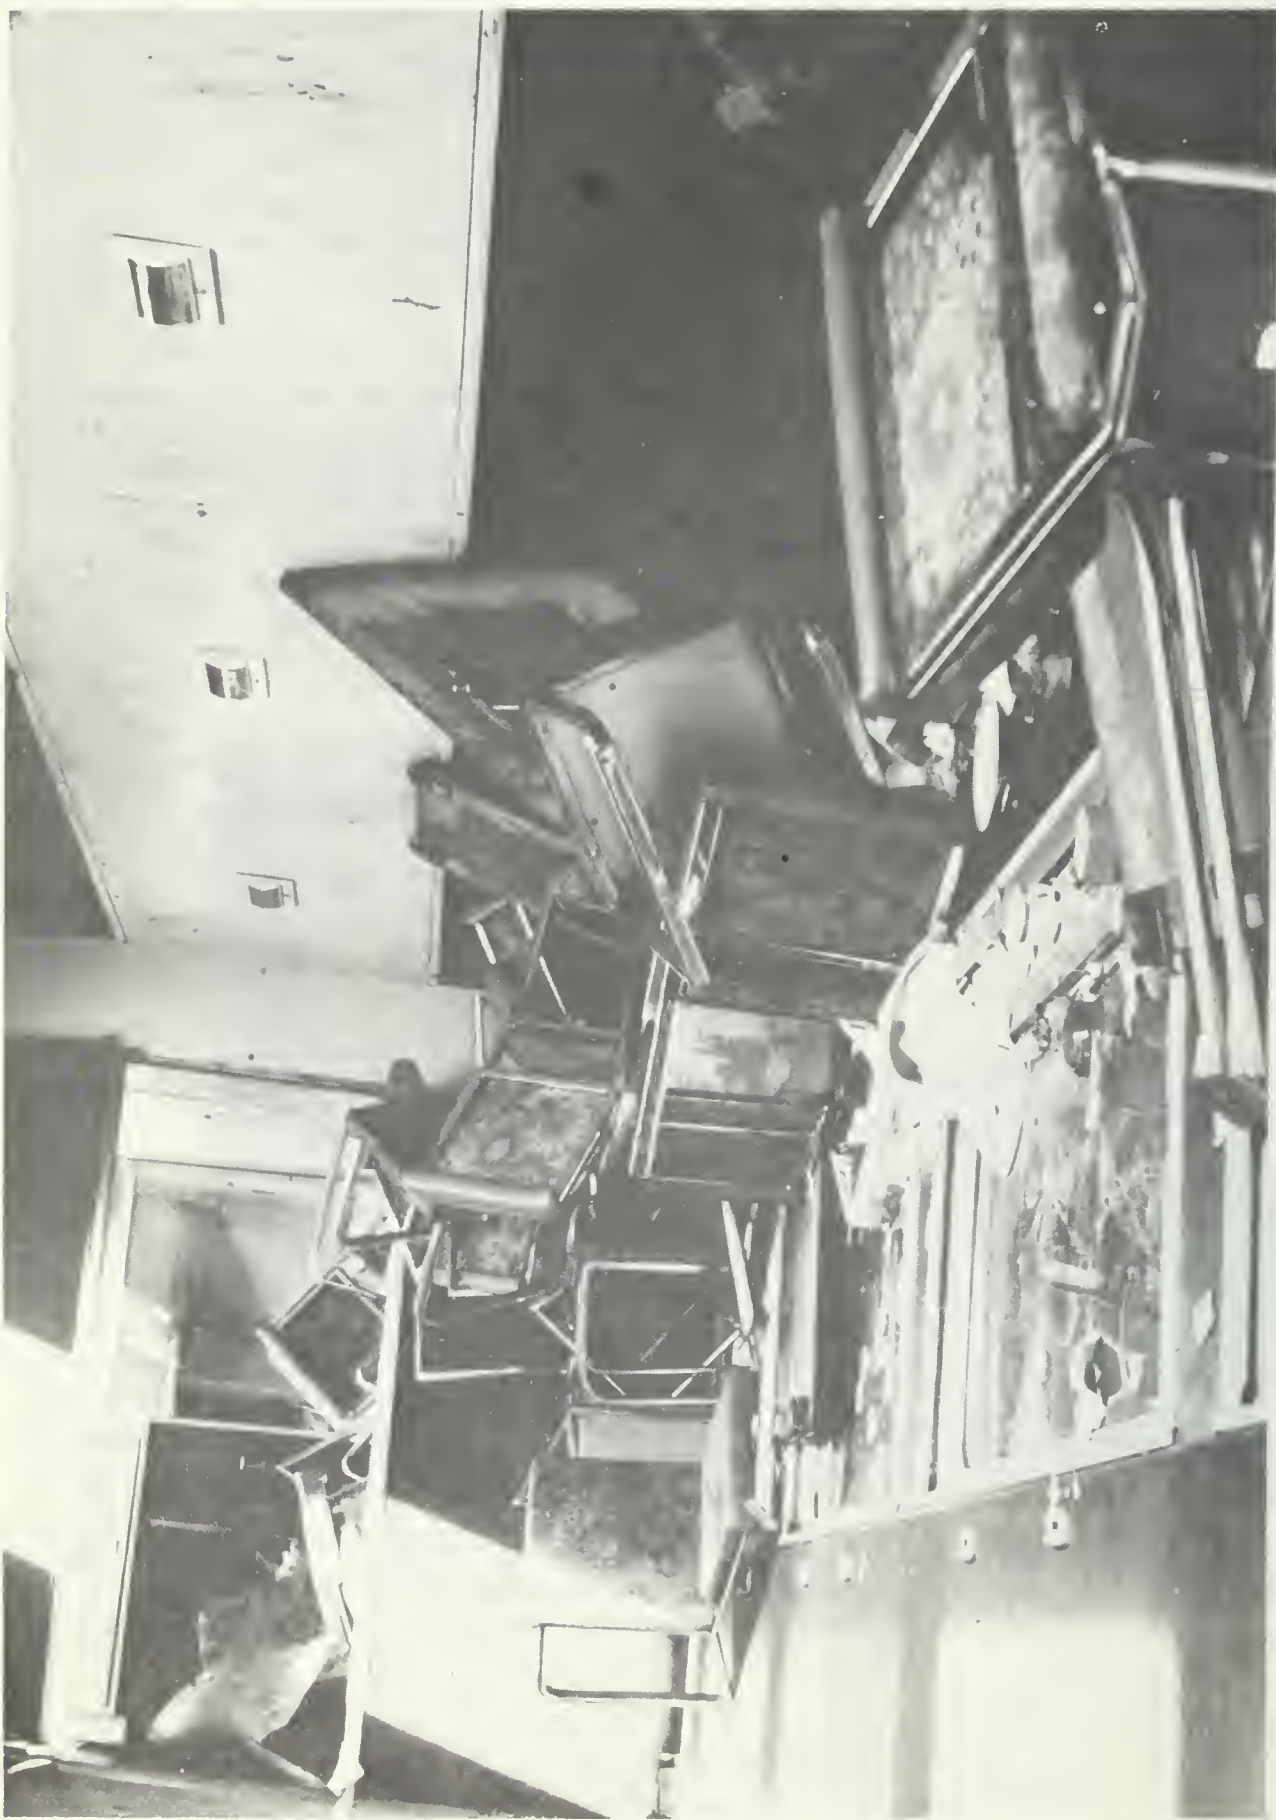
Figure 2. Loose and disarrayed furniture in the dining car.
